CIA/PIR-1001/64 March 1964

CENTRAL INTELLIGENCE AGENCY
PHOTOGRAPHIC INTELLIGENCE REPORT

SAN ANTONIO DE LOS BANOS AIRFIELD

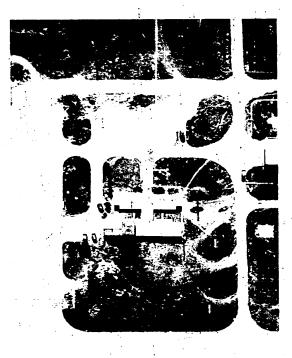
FIGURE 6. CONTROL TOWER

The main control tower is located between the two large concrete parking areas on the South side of Runway One and consists of an H-shaped, single-story building with a rectangular tower rising from the NE corner of the building (Figure 6).

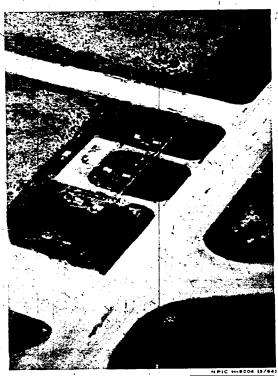
FIGURE 14. FUEL-LOADING PACILITY

POL (Petroleum, oil and lubricants). A pump facility for loading fuel trucks is located along the taxiway extending North from the SW end of Runway One (Figure 14). The facility is fenced and served by a concrete drive-through ramp. Within the fenced area are two small support sheds and four probable underground tanks with access covers. The four small sheds immediately South of the fenced area may also cover underground tanks. Two additional underground POL storage facilities have been constructed along the taxiway at the South end of Runway Three. Both installations are fenced and have drive-through roads (Figure 15).

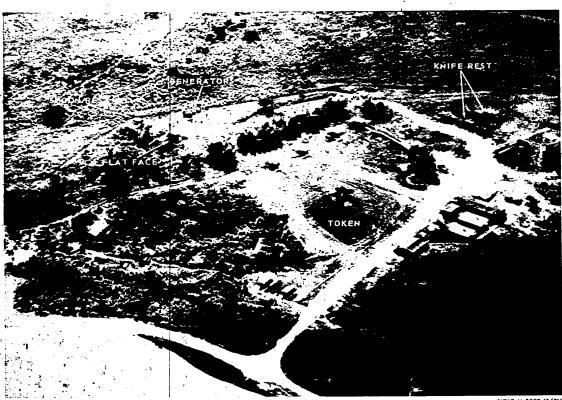
FIGURE 19. RADAR SITE

Active radar, navigational aid and communications sites are annotated on Figures 19 and 20.

A large radar installation is located at the East end of Runway Two, adjacent to the taxiway. This site, as of contains the following identifiable electronic equipment: TO-KEN, SPOON REST, FLAT FACE, KNIFE REST, STONE CAKE and BAR LOCK radars. A Ground Control Approach radar is located on the South side of Runway One near the control tower. Two navigational aids are located directly SW, 1,500 and 14,000 feet from the end of the concrete section of Runway One.
